UNITED STATES ENVIRONMENTAL PROTECTION AGENCY
REGION II
2890 WOODBRIDGE AVENUE
EDISON, NJ 08837

DATE: MAY 19 2016

SUBJECT: Removal Site Evaluation for the Beechnut Nutrition Site (CERCLIS #: NYD066809203), Canajoharie, Montgomery County, New York

REMOVAL SITE EVALUATION FOR THE
BEECHNUT NUTRITION SITE
CANAJOHARIE, NY
SITE ID# A26B

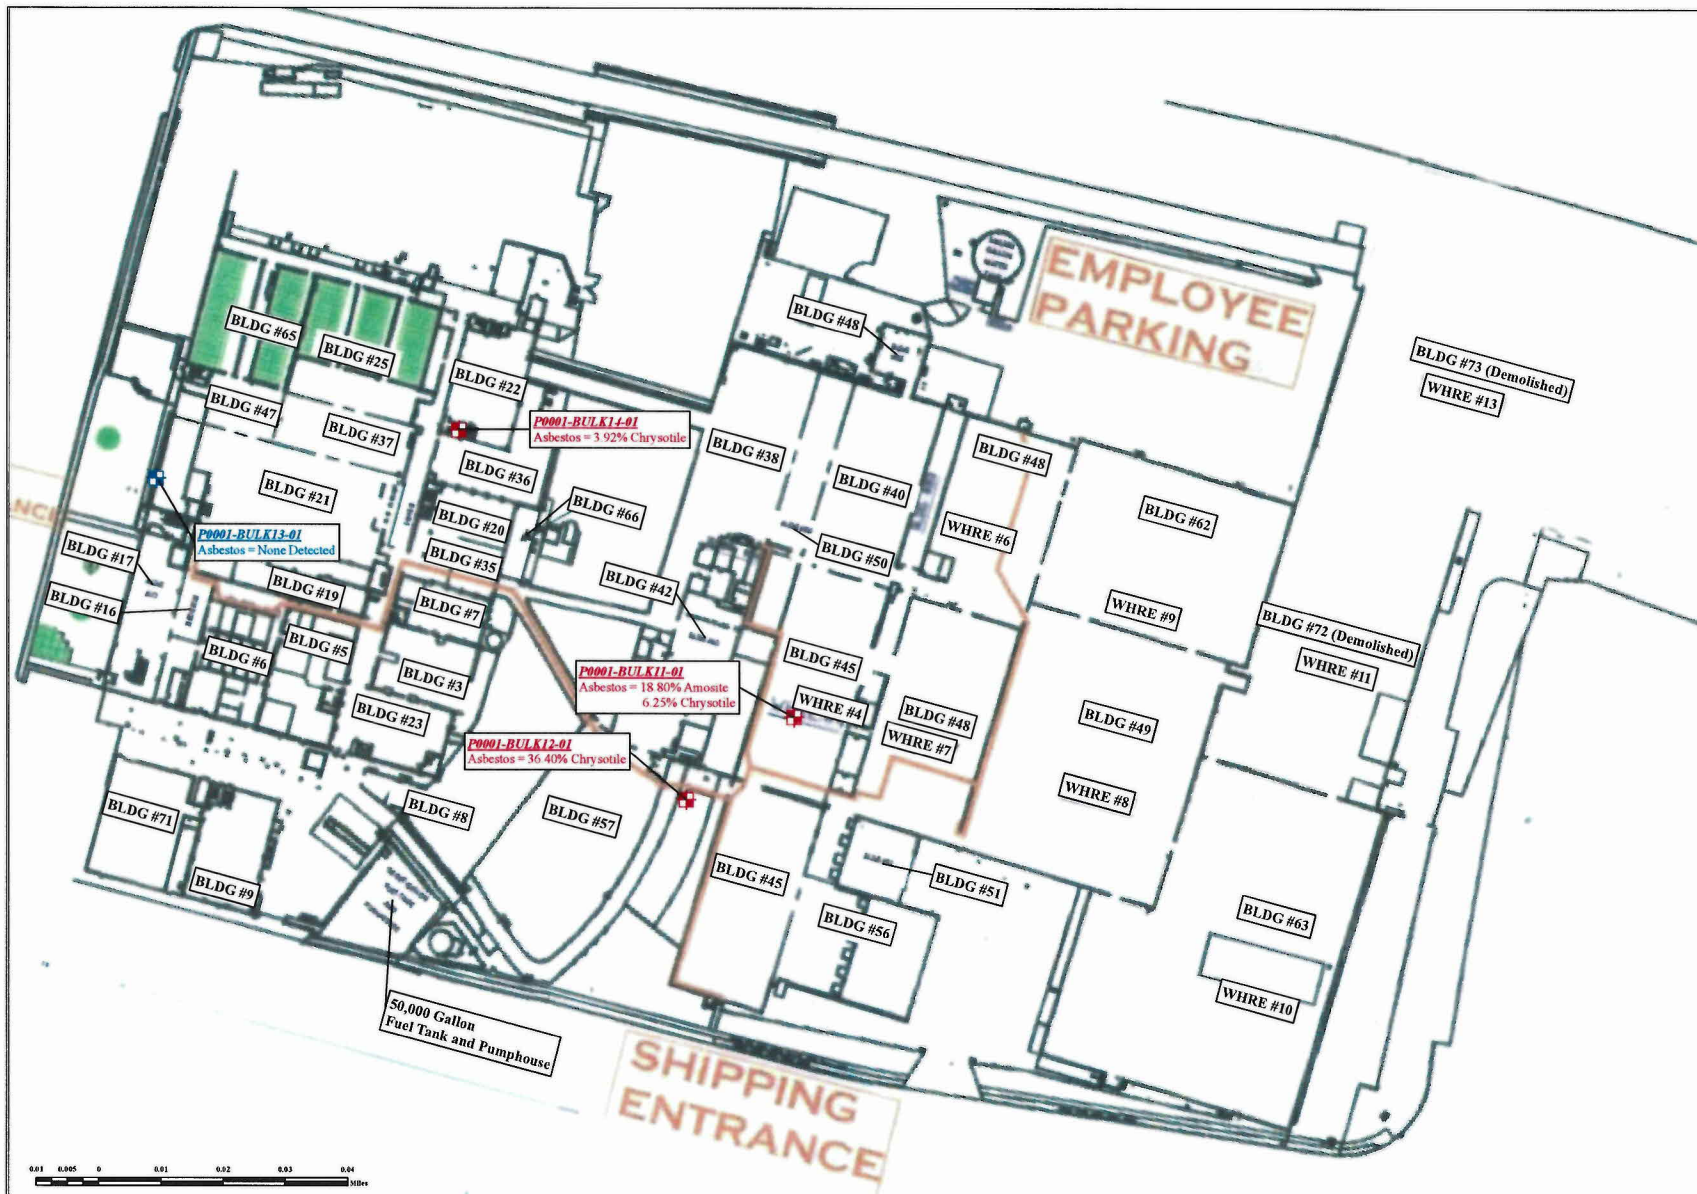
Figure 3: Interior Bulk PACM Analytical Results Map

Results indicated a total of 4 samples positive for containing asbestos. Sample BULK06, located in an exterior pile, was found to contain chrysotile asbestos at 1.32%. This location was the sole sample collected of masonry block, which was coated with a white paint-like material. Sample BULK11, pipe insulation associated with the abandoned abatement area in Building #45, was found to contain 18.8% amosite and 6.25% chrysotile asbestos. Sample BULK12 was material collected from inside the roll-off containers suspected of holding ACM. Results indicated that this material was found to contain 36.4% chrysotile asbestos. The pipe wrap collected from the retort area, BULK14, was found to contain 3.92% chrysotile asbestos.

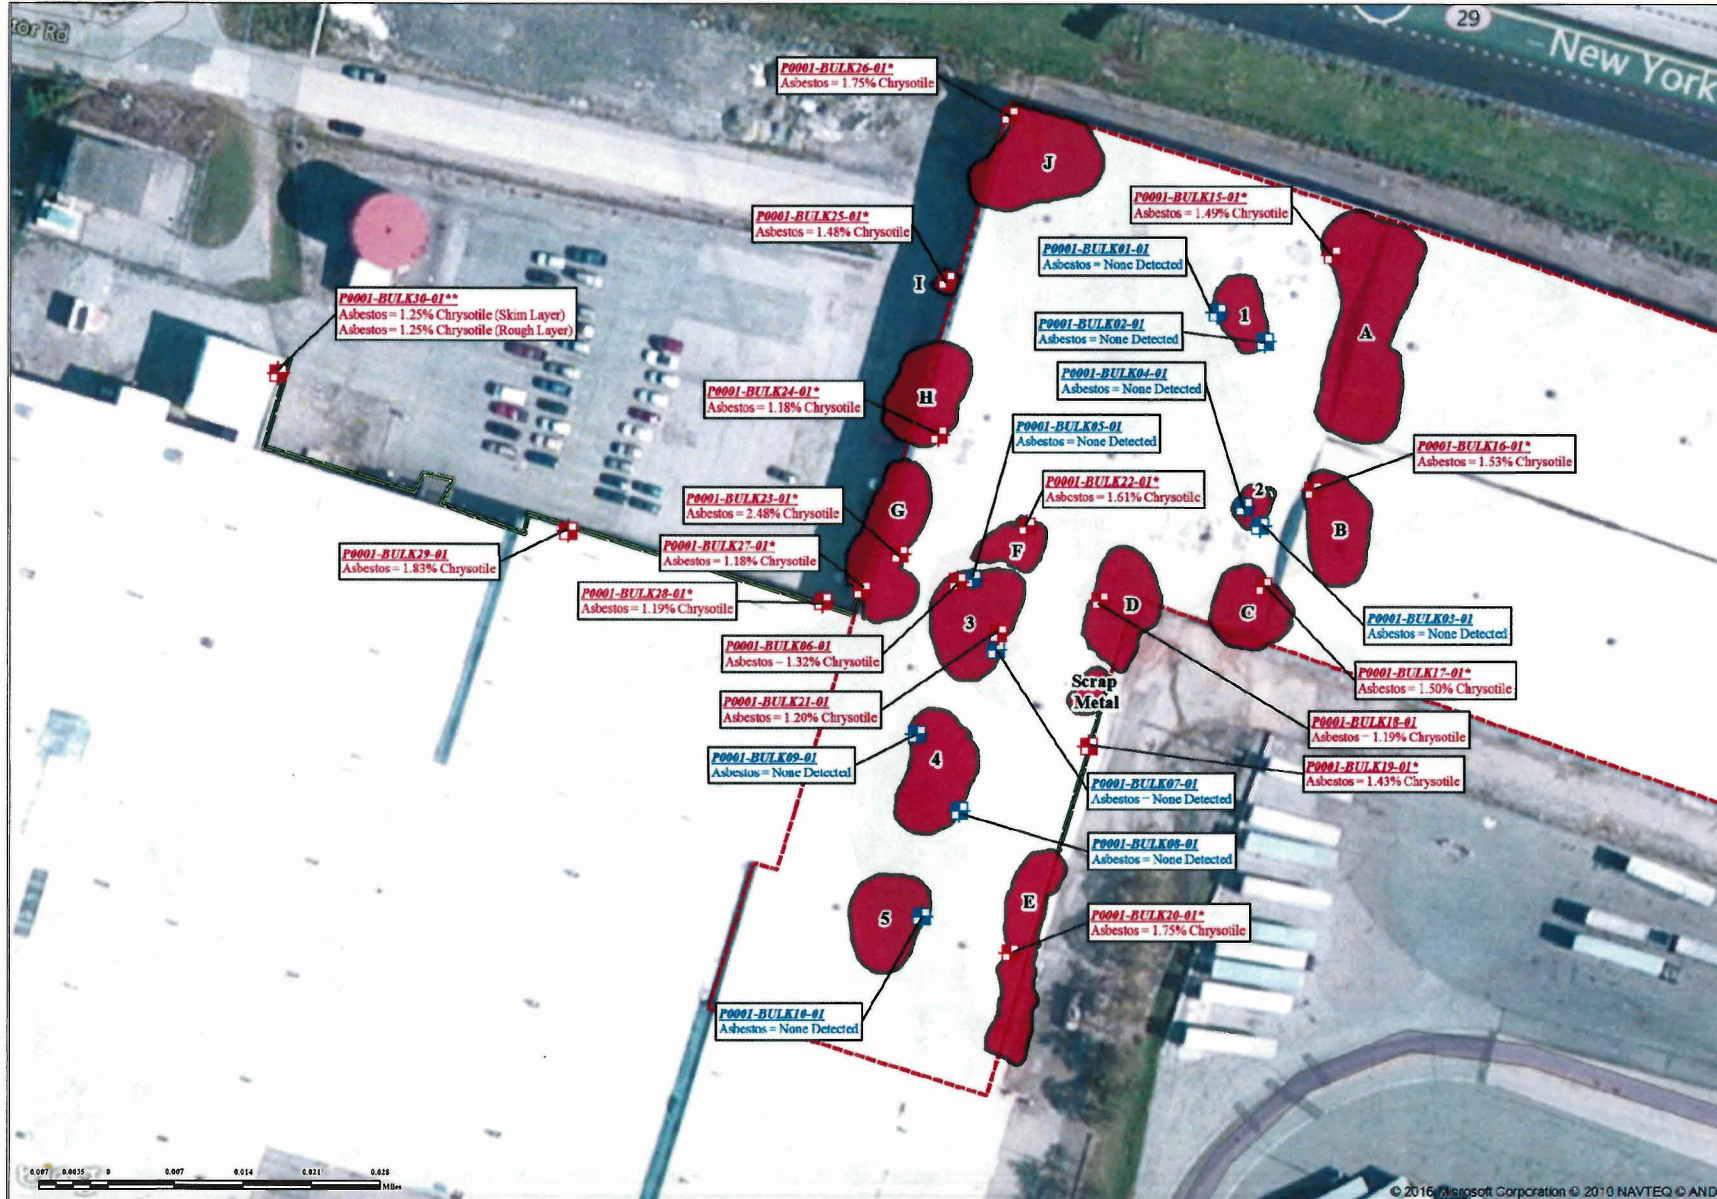
Figure 4: Exterior Bulk PACM Analytical Results Map

The laboratory separated each sample and analyzed the coating material independent of the mortar/cinderblock. All coating samples were found to contain asbestos. The white coating associated with the masonry blocks and exterior walls was found to contain between 1.18 and 2.48% chrysotile. Asbestos was additionally found in the mortar or wall material of sample location BULK30. The laboratory noted all asbestos-containing material was in friable condition. Asbestos was not detected in any other sample of mortar or masonry block analyzed. Analytical data tables and sample location maps are located in Attachment A.

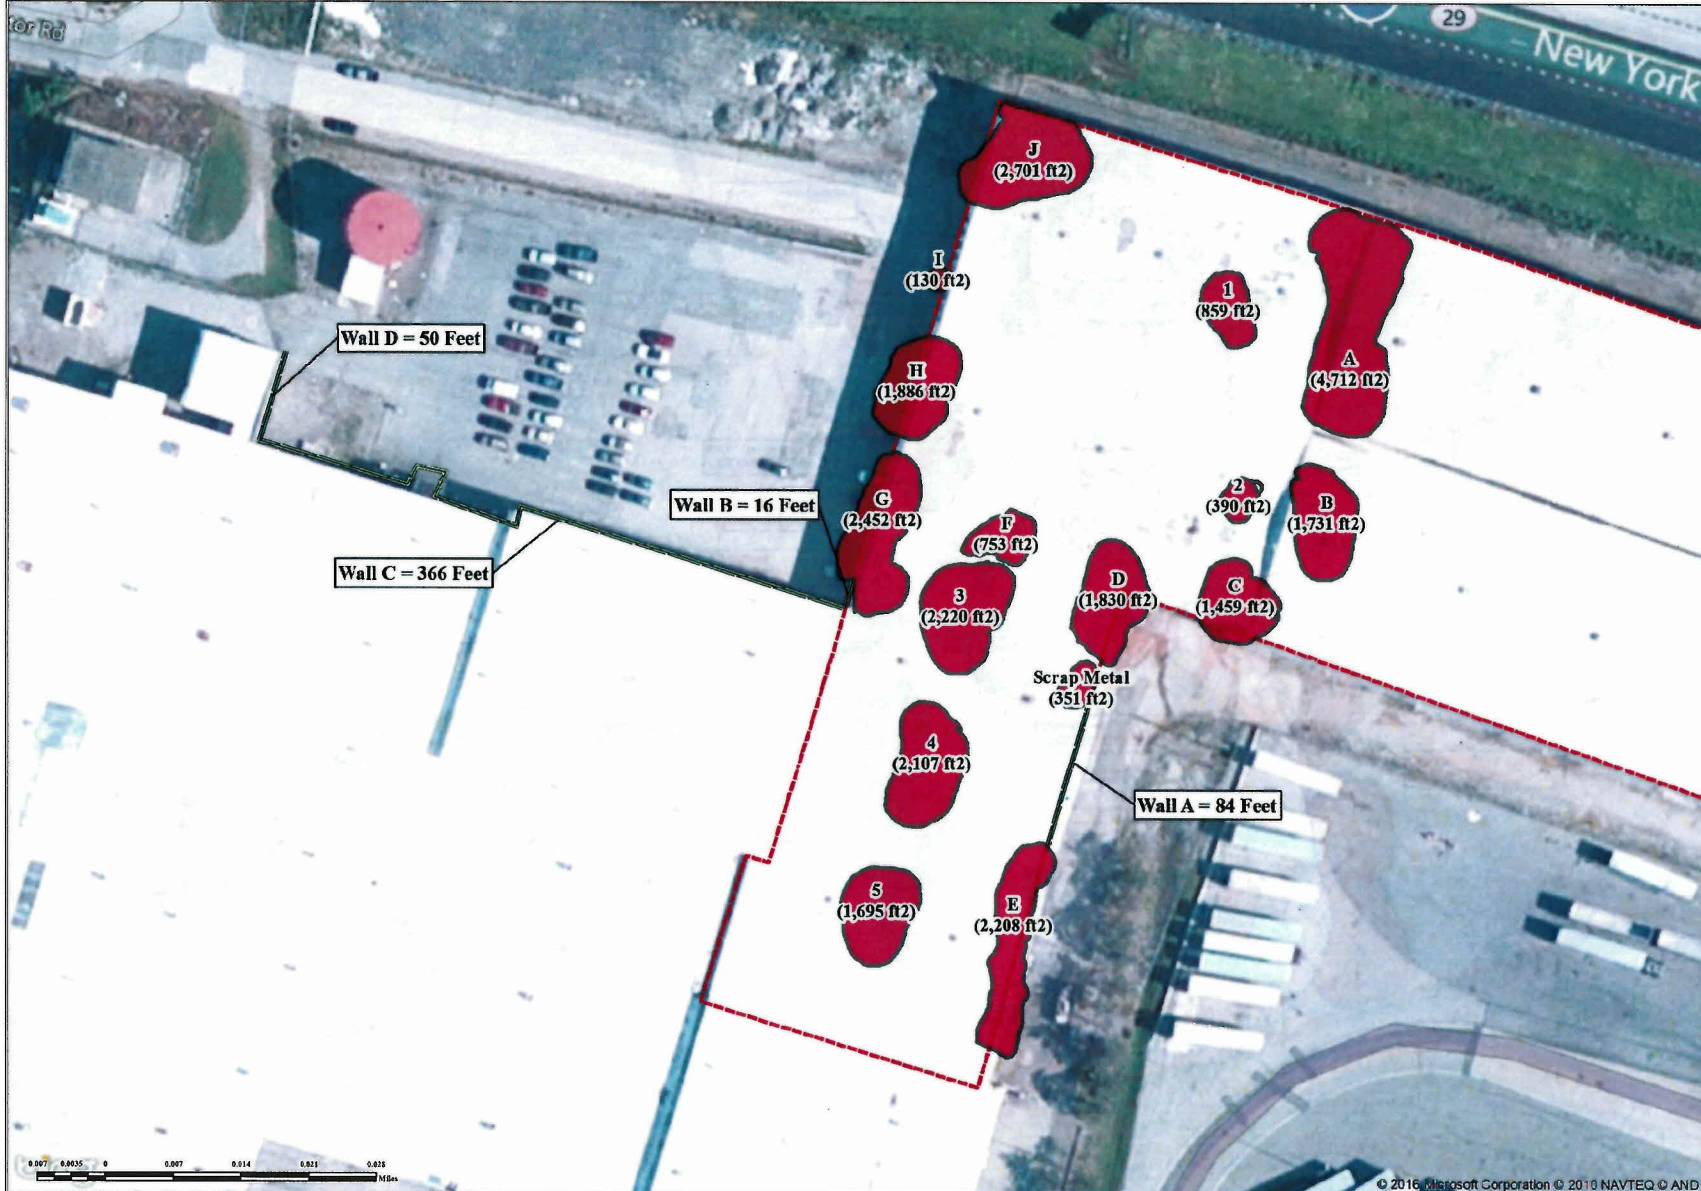
Figure 5: Source Area Map

Notes:
1.) Waste pile nomenclature developed by the EPA OSC.
2.) Total linear feet of wall = 516 ft.
3.) Total area of waste piles = 27,484 ft².
